2D Modeling of the Creeks

Project Prioritization Criteria Matrix (DRAFT)

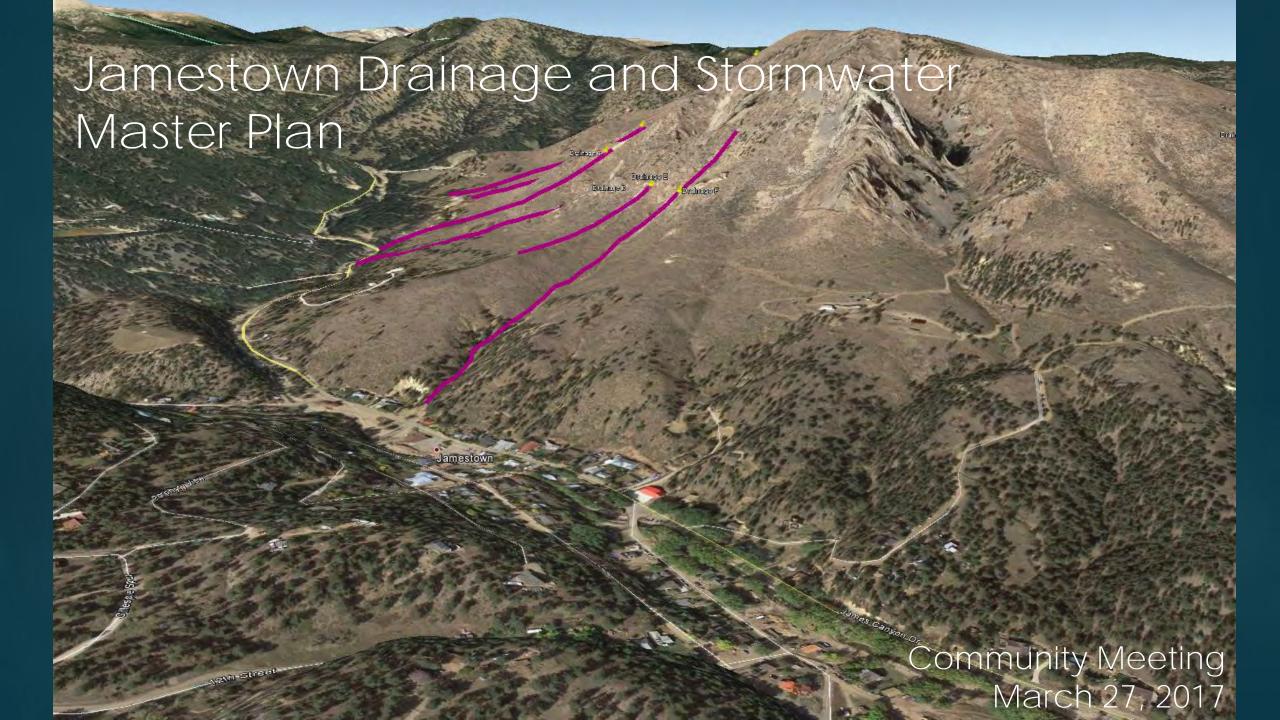
Problem Drainage Areas
	(Determined from the Open House)
Number	Description of Drainage Problem
1	The flow from 16th Street discharges along the south bank of James Creek, causing severe erosion problems.
2	The drainage along the north side of Main Street does not easily get into the Howlett Gulch culvert.
3	runoff from the washing of the Fire Trucks drain through 58 Mill Street.
4	How will the raising of Main Street bridge impact drainage at 58 Mill Street?
5	"Spruce Lake": Every time it rains or snows a "lake" appears. The ponded area overtops and flows to Mesa Street. Sandbags are being used to prevent Jan Reid's house (downstream of the Spruce Street on Mesa Street) from being flooded on a regular basis.
6	The inlet at the end of 16th Street has been retrofitted to collect storm runoff and has become unsafe to the public.
7	The flow on Overland Road sheet flows along the road. The slope of the road is very steep and the runoff flows into town.

8	There is a 24-inch culvert at the base of Buffalo Gulch. 120ft of the ditch, from the culvert to the creek, was poorly constructed and does not drain. The house nearby runs four (4) dewatering pumps at a time to keep the house dry.
9	Crown on the road was removed after flood when the streets were repaired and regraded. This changes the drainage pattern to the roadside ditches and nearby inlets. This enhances flooding problems as the street does not direct the runoff to the ditches along the road way. The ditches do not collect runoff since the improvements have been made. This problem area occurs throughout the town (there are 3 example locations on the map).
10	Drainage problems occur at the southern end of 16th Street.
11	The culverts on Spruce are clogged and crushed.
12	Road drainage runs along the north side of Main Street and thru the front yard of 58 Mill Street until it cuts across 15th Street (a dirt road). This damages the road until it reaches a culvert that diverts the flow under the road to James Creek.

13	At the school runoff is collected in an inlet. This inlet gets clogged easily and runoff overtops the sump condition and into the school yard, ultimately to the school. The inlet does not appear to collect any local drainage, only flow from the upstream culvert that discharges overland to the grate.
14	The inlet along Mesa Street is clogged and easily filled with ice and debris.
15	Runoff is being collected at the end of Anderson Hill Street, causing potholes.
16	The existing inlets at the eastern end of Mesa Street does not collect runoff. If the inlet collected runoff then the flooding at Main Street and 12th could be minimized.
17	At the downstream end of Gillespie Gulch is a house. This house was destroyed by the flows in Gillespie Gulch during the flood. The flow from Gillespie Gulch is concentrated flow. The concentrated flow causes drainage problems. Gillespie Gulch plans are intended to remedy this flooding problem.

18	The runoff travels from the school to 16th Street to Mesa Street. The runoff does not travel to the drainage swale downstream of Mesa Street. The flows down Mesa Street are not distributed, and not concentrated to one point. This enhances the drainage problems.
19	There are drainage issues at the top of drainage way #8.
20	The inlets on Lower Main are supposed to collect drainage from the intersection. The inlets do not collect runoff. The ditch/drainage wat where the pipes discharge to does not have a positive slope, therefore runoff pools in the ditch causing an unwanted mosquito habitat.
21	There is a lot of runoff that travels down Skunk Tunnel. The runoff carries debris from high up in the basin. The road base gets washed away when it rains.

Problem Drainage Areas
	(Determined from the Open House)
Number	Description of Drainage Problem
22	There is a lot of runoff that concentrates at the end of 16th Street, just upstream of Steve's house. The inlet at the school gets clogged easily. A grate was added after the flood. Inlets in the mountains become clogged easily. The ditch on 16th Street gets clogged often and does not collect runoff.
23	A stone wall has been constructed along the edge of the road. At the edge of the wall is a drainage ditch. Since Anderson Hill has a very steep drop off on the opposite side of the street, cars ride close to the wall/ditch. Since the street is very narrow, the cars ride too close to the ditch and occasionally the cars get a wheel stuck in the ditch. The car then is dragged across the wall, scrapping the side of the car.
24	The drainage at the end of Slaughter House Road (Rose M) washes to the end of the street, causing massive erosion problems and flooding. The drainage ditch along the road is located on the high side of the street.

25	The street is flat, runoff ponds often causing potholes.
26	The western end of Mesa Street is steep, causing clogging of inlets and culverts. The side ditches are repeatedly filled with sediment and becomes rutted with any rain, causing issues downstream.
27	The drainage and culvert on the west side of the property clogs often if it is not kept clean. The fire area drains directly to the culvert, clogging it often.
28	The drainage ditch along 16th Street is often clogged. This ditch is deep, and has trapped cars. A drainage pathway has been cut through the yard of the residence at 100 Mesa Street.
29	The ditch to the east of the Fire House causes access issues. Cars bottom out on the ditch. A culvert should be constructed.
30	Flows from the drainage pathway behind the Merc flow to Main Street, over the road and ultimately to the creek. Erosion occurs on Main Street and the downstream pathway.

31	There is a large offsite drainage area from the Hills to the North of the town that drains to Main Street (between Ward and Lower Main Street).
32	Hittle Driveway debris flow issue
33	Potential mining contamination source

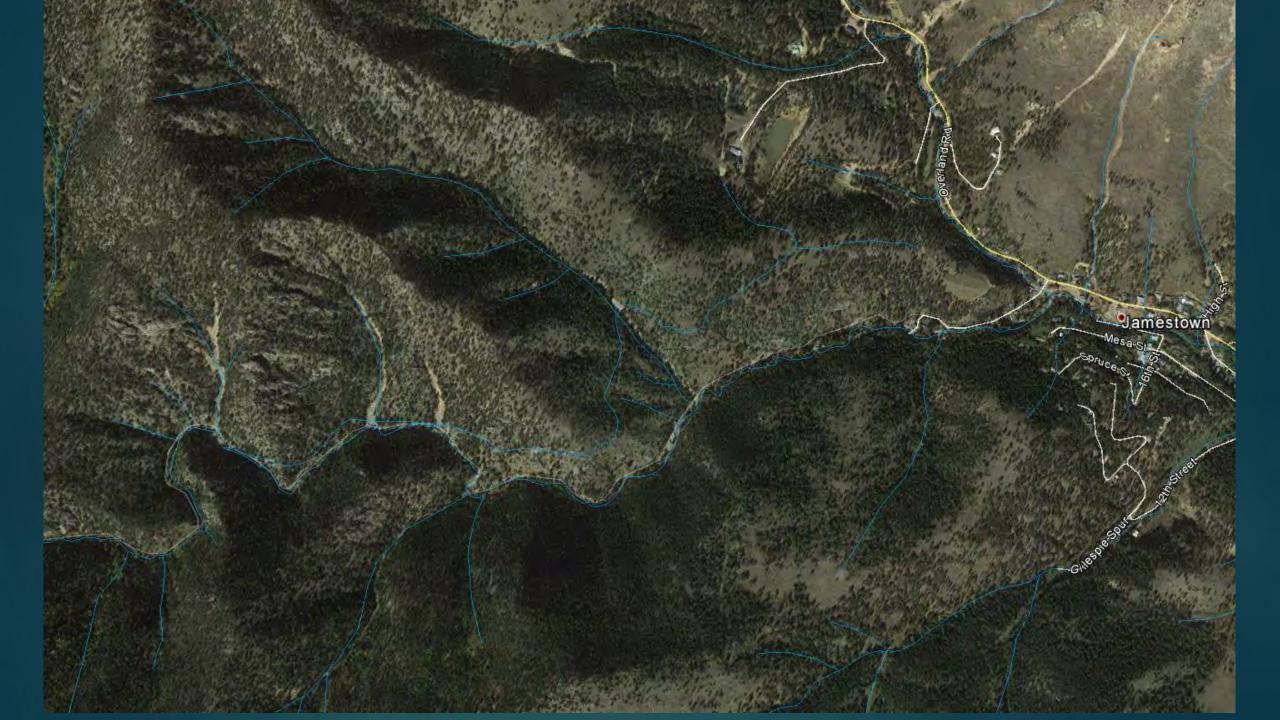
Water Depth Maps
