Jamestown Drainage and Stormwater Management Master Plan

FINAL REPORT

-Town of Jamestown, Colorado

July 2017

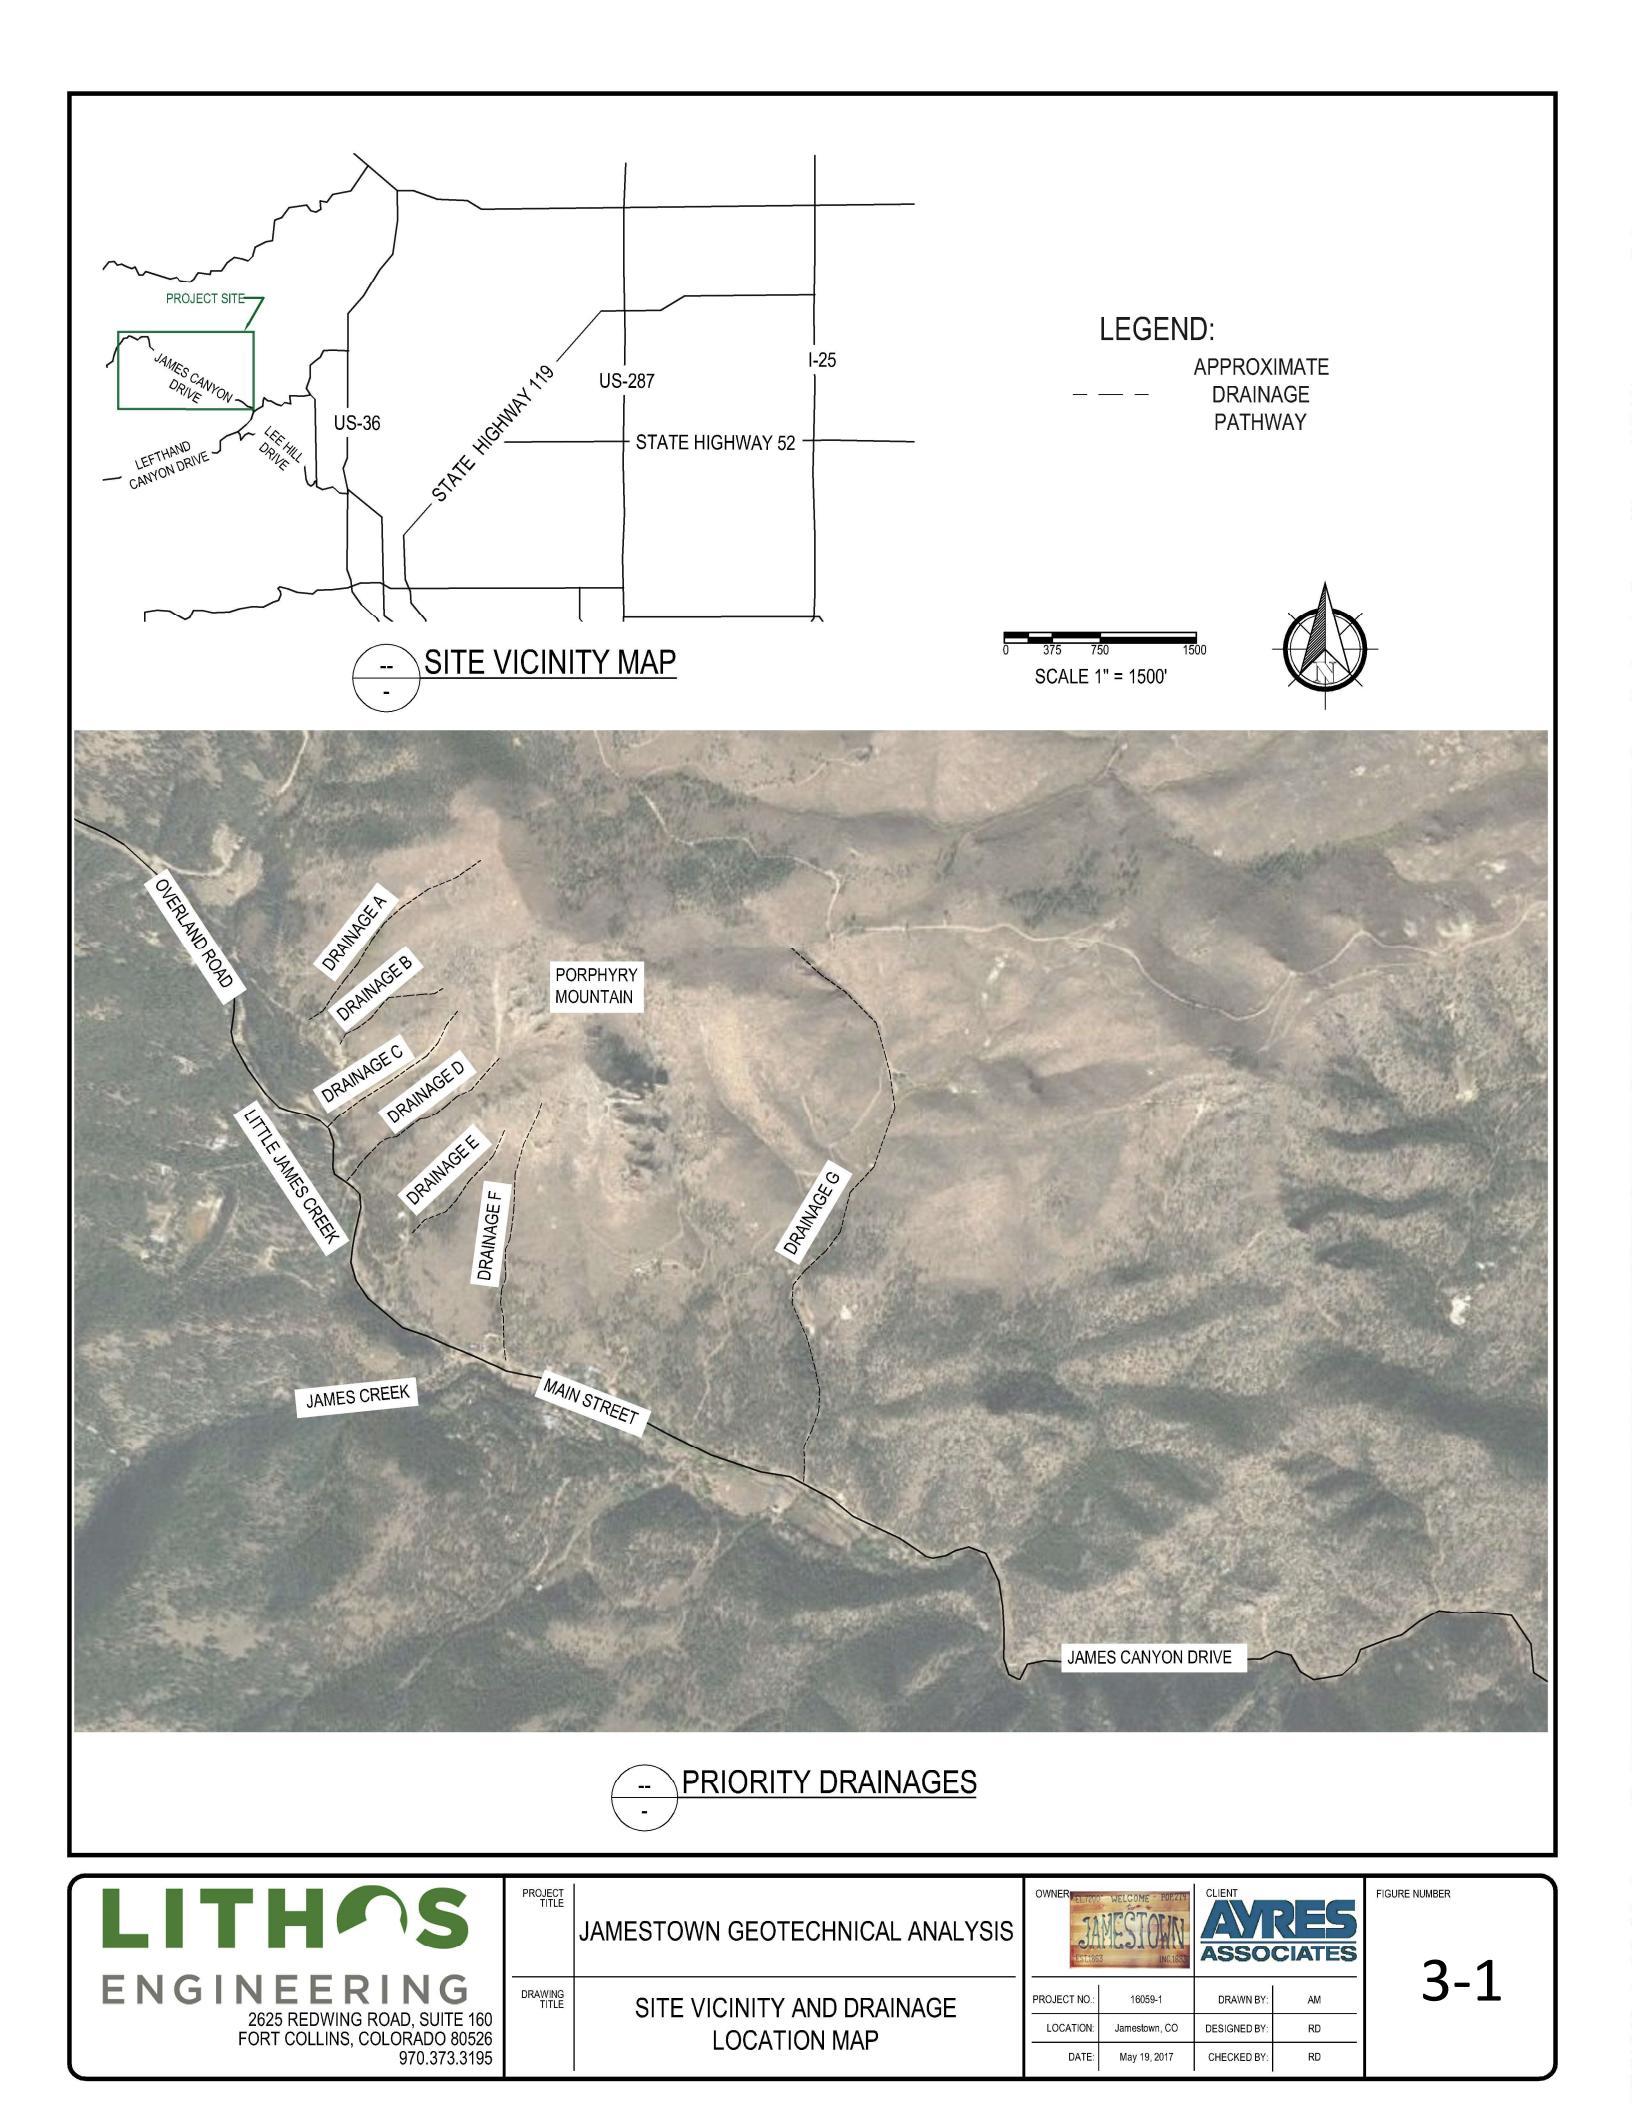
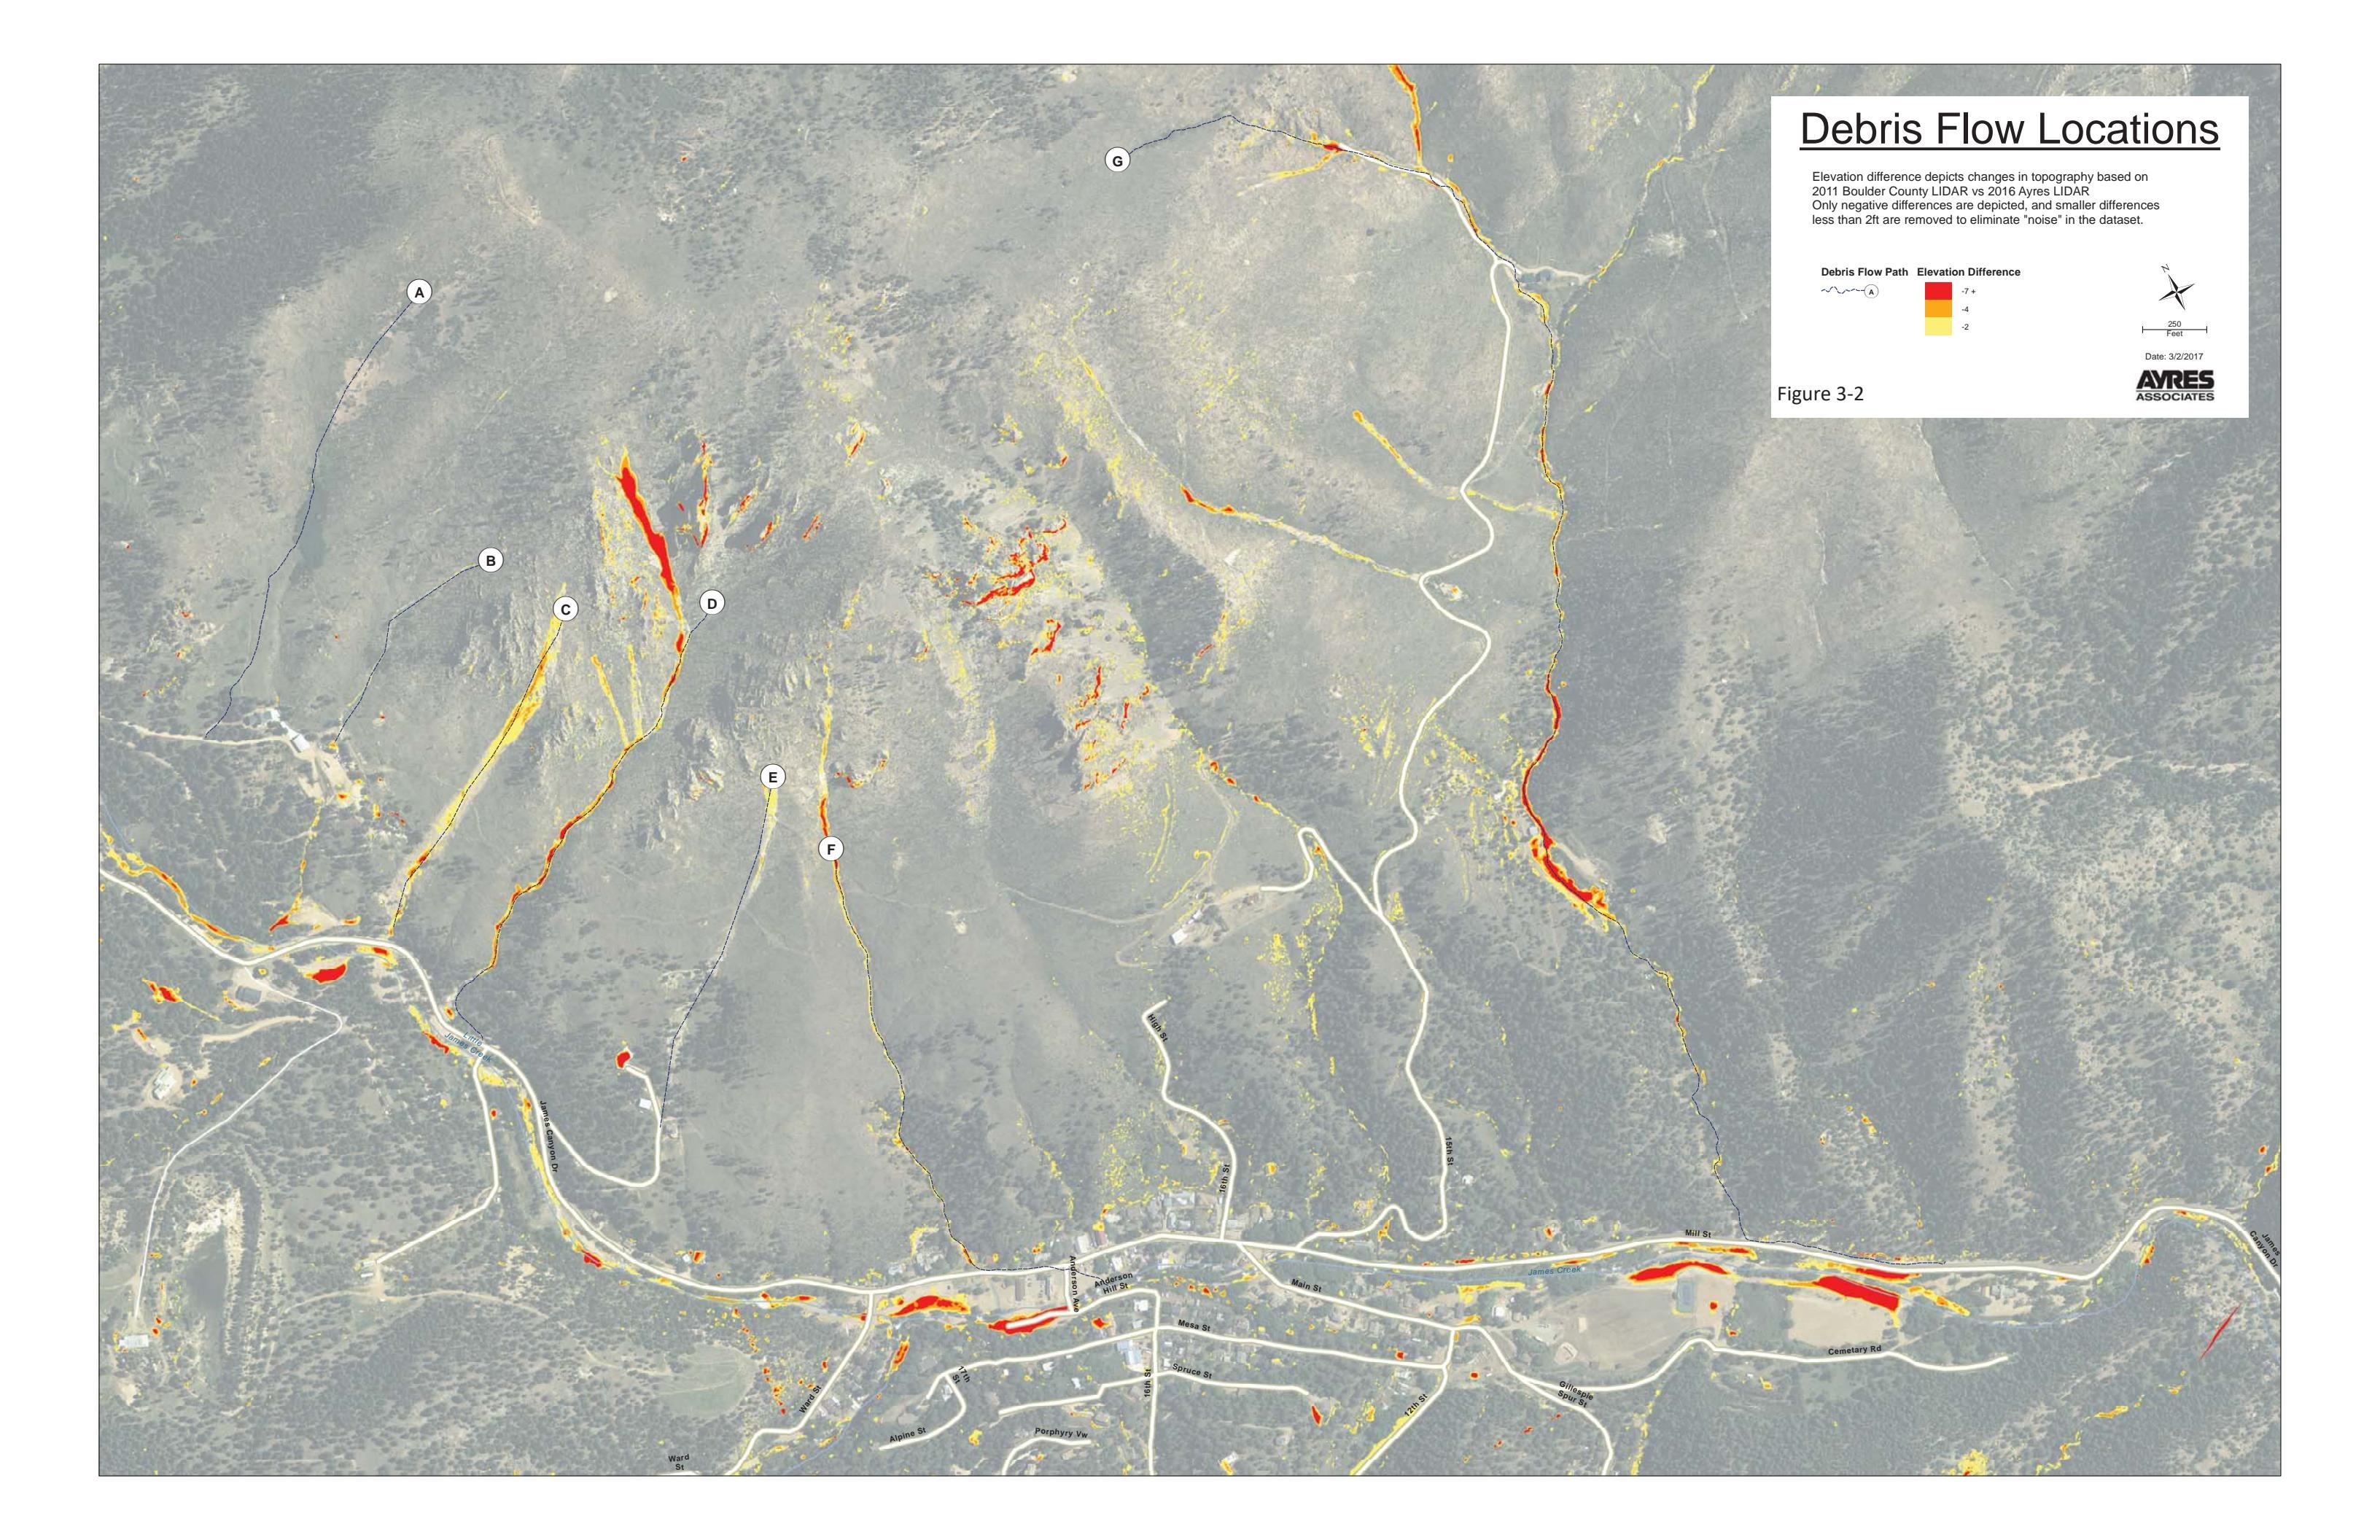
Ayres performed a topographic comparison of LiDAR data collected by Boulder County in 2011 (preflood) and by Ayres in 2016 (post-flood) for the area north of town. The results of the comparison are shown in Figure 3-2 and only negative differences, or elevation losses, are depicted. The elevation comparison revealed significant elevation changes (seven feet or more of elevation loss) occurred in four of the priority drainages. Changes of less than two feet were removed to eliminate noise from vegetation and seasonal fluctuations It is reasonable to assume a majority of the elevation changes observed in the drainage channels are the result of the 2013 debris flows, therefore, the LiDAR comparison data as the estimated 2013 debris volumes conveyed by each drainage was used. The actual debris volumes could have been slightly larger, or smaller than what was estimated using the LiDAR data. It is important to note the LiDAR volumes do not include water, which we assumed to be approximately 30% of the total debris flow volume. Significant changes in topography between 2011 and 2016 were also observed in the rock avalanche landform (see Figure 3-2) on Porphyry Mountain which indicates it is still active.

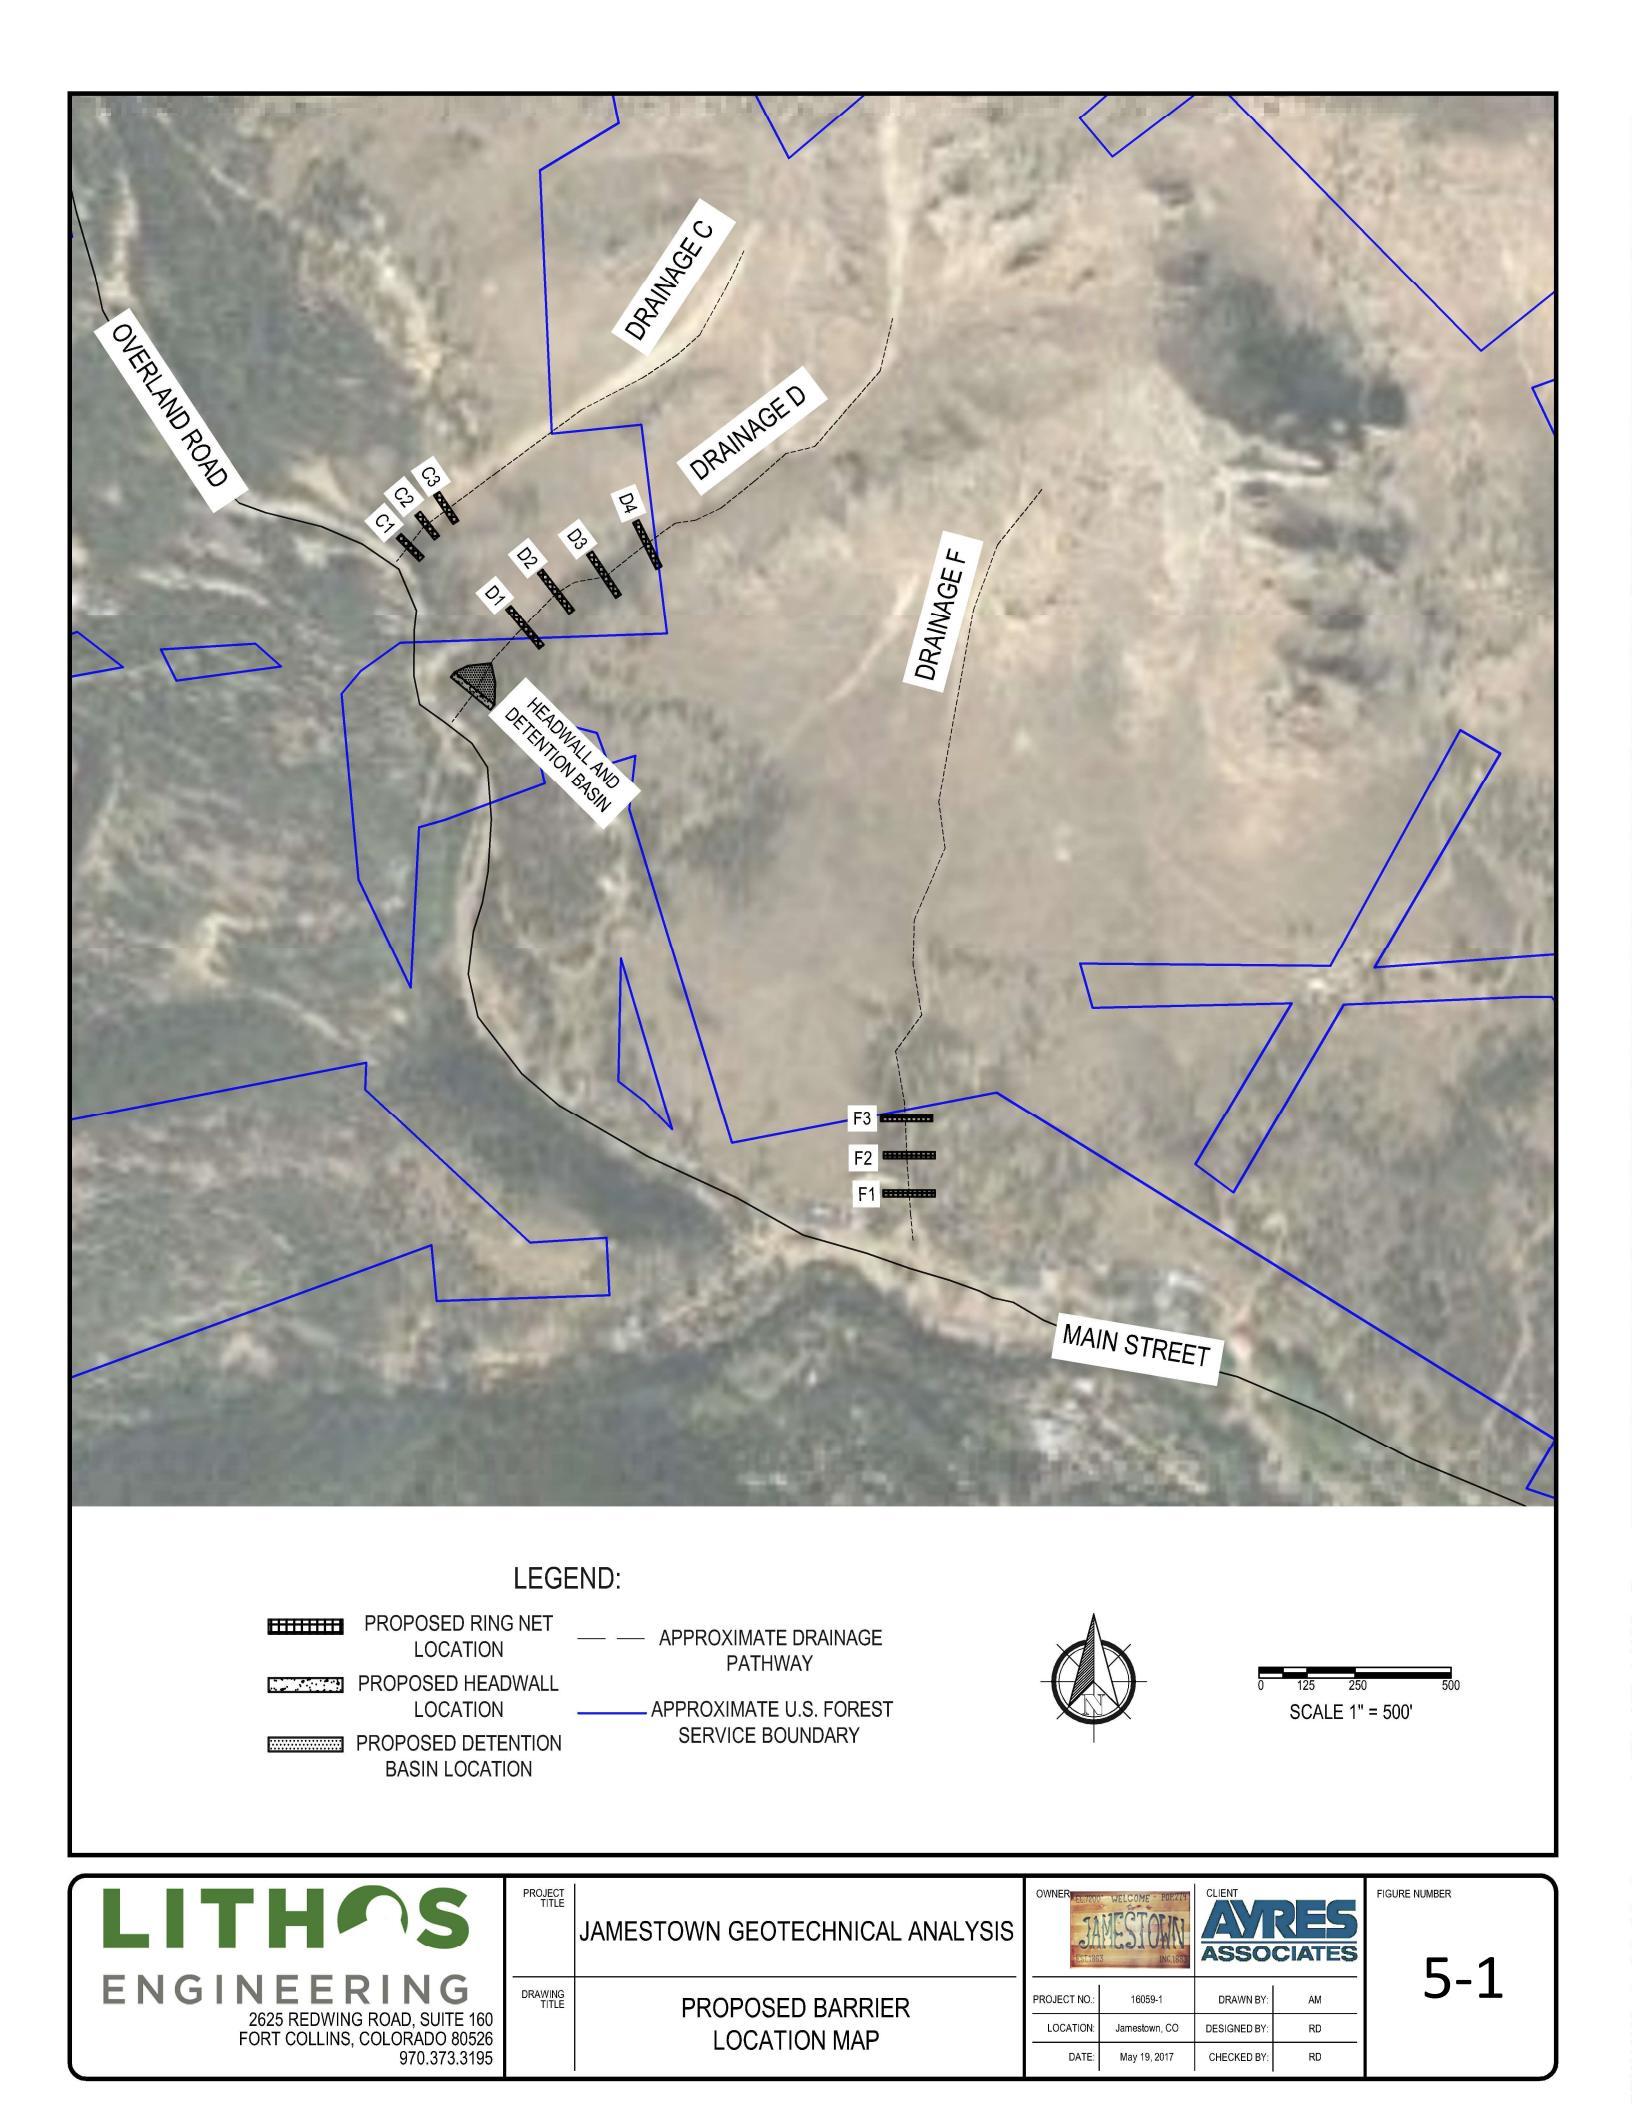
Drainage F, also known as Howlett's Gulch, lost just over 4,800 yd³ of material between 2011 and 2016 and claimed the life of a Jamestown resident during the 2013 debris flows. Based on field observation, the drainage has viable conditions for ring net installation starting approximately 100 feet from the road where the channel steepens and the viable conditions continue all the way upstream to the flow initiation area. The channel is scoured to bedrock through the majority of the drainage. Sparse vegetation and loose soil, some of which may be historic mine tailings, were observed on the channel flanks. The drainage exits Jamestown limits and intersect USFS land approximately 430 feet upstream from the road, as shown in Figure 5-1.

Lithos recommends the installation of at least three VX160-H6 ring net barriers, or an equivalent product, in the portion of the drainage that is not on USFS land, between 100 feet and 430 feet from the road. The combined retention capacity of the three proposed barriers is estimated at approximately 2,200 yd³ of debris, which is just less than the 50% 2013 debris volume. If feasible, installing a fourth barrier 600 feet upstream from the road on USFS land will add additional protection. A fourth barrier is estimated to increase the overall retention capacity by 750 yd³ in the drainage and provide a barrier positioned closer to the flow initiation zone source on Porphyry Mountain. The fourth recommended barrier was not included in the cost estimates discussed in Section 6.0.

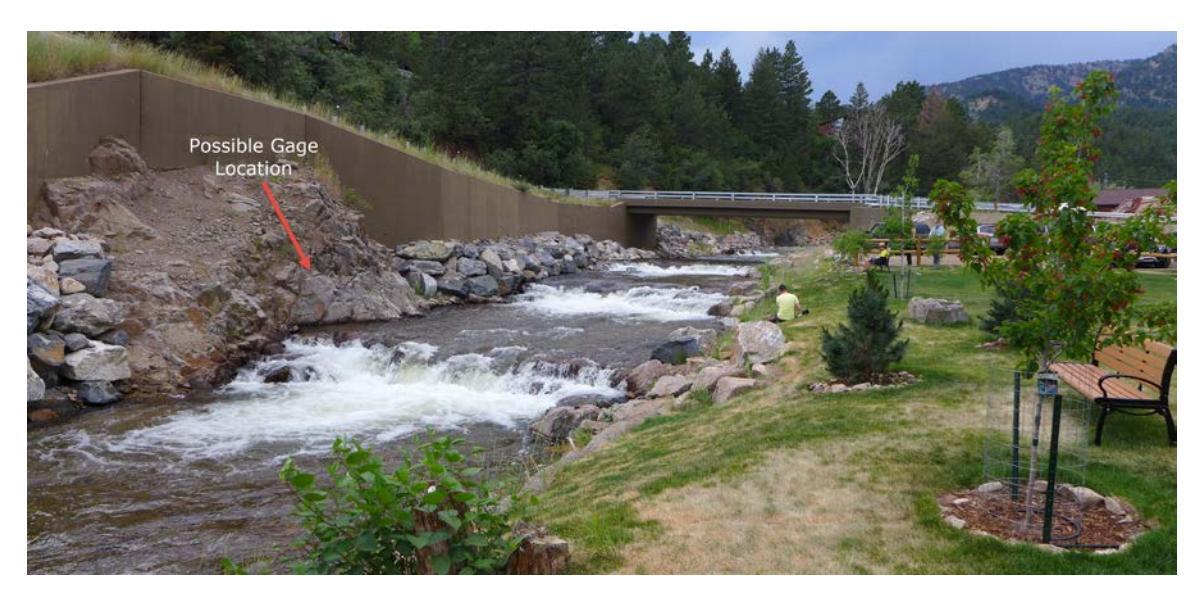
Figure 5-2. Recommended Creek Gage Location

To maintain awareness of flow conditions in James Creek it is recommended that a visual flow gage be installed in a highly visible location. A good location for this is on bedrock along the creek across from Town Hall and The Mercantile, near the Town Square. See Figure 5-2 for recommended location. Placement at this common gathering space will maximize usefulness of the gage.
